# The rehabilitation design of the Beaugregard Dam

C. Marcello<sup>1</sup> and P. Meda<sup>1</sup>

<sup>1</sup> Ing. Claudio Marcello S.r.l., Via Visconti di Modrone 18, 20122 Milano, Italy

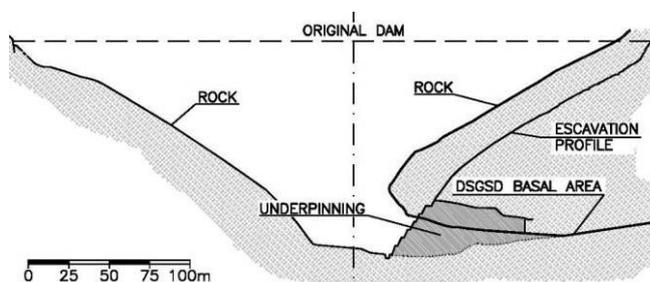
Figure 4: Downstream view

Figure 4 shows the prediction of the rock profile in the design phase, the rock profile during the excavation and the DSGSD basal area.

During the construction phases, the inclusion of glacio-fluvial sediments in the lower part of the slope requested the removal of the damaged rock and the construction of an inspectable concrete underpinning structure, also shown in Figure 4.

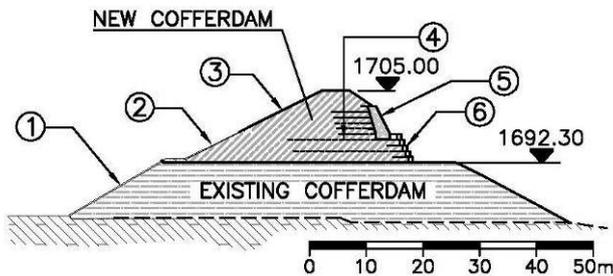
Figure 5: Cross section of the cofferdam

Figure 5 shows schematically the cross-section of the cofferdam with the crest at el. 1705 m a.s.l. At the end of the work the cofferdam will be removed down to el. 1698.00 m a.s.l.
